Manhole Inspection Summary

Manhole # S33K__010MH

Location Address: **rear 110 w conway st**

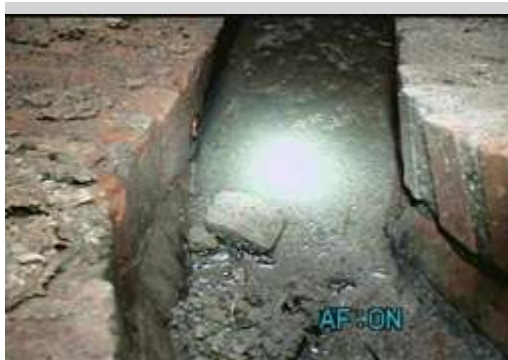
Defect 3

Condition: ☐ Sound ☐ Cracked ☐ Root Intrusion ☐ Deteriorated ☐ Leaks ☒ **Debris**

channel debris

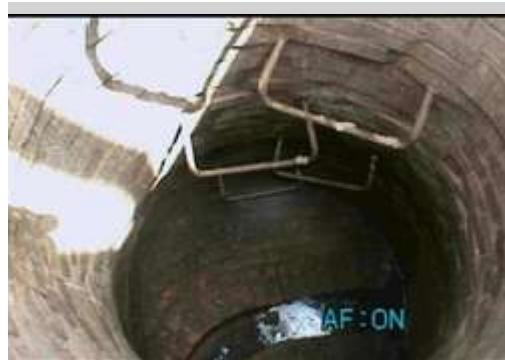
Defect 2

Count: **5** Missing: **0** ☒ **Corroded**

steps

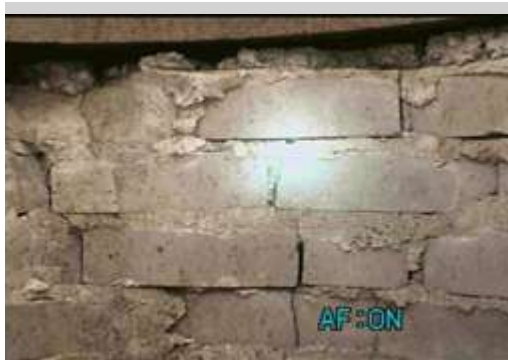
Defect 1

Condition: ☐ Sound ☒ **Cracked** ☐ Root Intrusion ☐ Loose Brick ☒ **Deteriorated**

chimney loose bricks,
cracked,deteriorated,
frame adj

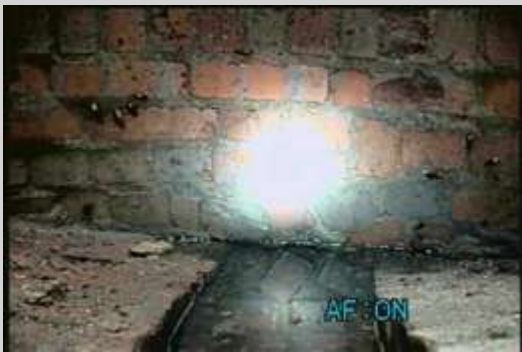
12 O'Clock Outflow

water blocking 12 cant see in pipe
